PENNSYLVANIA  
VALLEY-HI EAGLE LAKE DAM

NDS I.D. No. PA - 00186  
PENNDER I.D. No. 29 - 33

PHASE I INSPECTION REPORT  
NATIONAL DAM INSPECTION PROGRAM

GAI CONSULTANTS, INC.  
570 BEATTY ROAD  
MONROEVILLE, PENNSYLVANIA 15146  
SEPTEMBER 1979

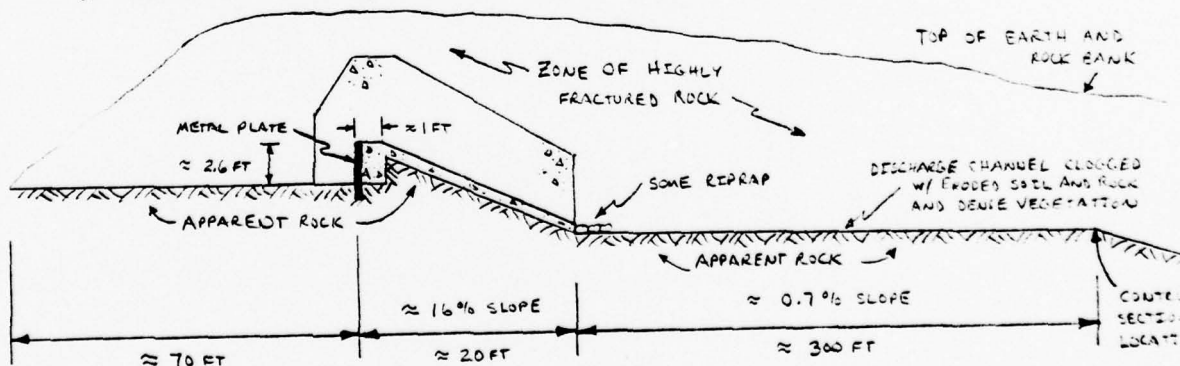
- PROFILE OF SPILLWAY : (NOT TO SCALE)  
 (PRIMARILY BASED ON FIELD MEASUREMENTS AND OBSERVATIONS)

- SPILLWAY IS A FREE OVERFALL, CONCRETE, TRAPEZOIDAL-SHAPED WEIR STRUCTURE WHICH DISCHARGES INTO A RELATIVELY FLAT OPEN CHANNEL. THE DISCHARGE CHANNEL IS PRESENTLY CLOGGED WITH FALLEN ROCK AND SOIL FROM THE UNPROTECTED SIDEWALLS, AND BY DENSE VEGETATION GROWING WITHIN THE CHANNEL. THUS, THE CHANNEL HAS LESS OF A CONVEYANCE CAPACITY, WHICH WHEN COUPLED WITH THE RELATIVELY FLAT CHANNEL SLOPE CAN LEAD TO ADVERSE TAILWATER CONDITIONS ON THE WEIR OUTFLOWS. WEIR DISCHARGES CAN BE DEFINED BY THE RELATIONSHIP:

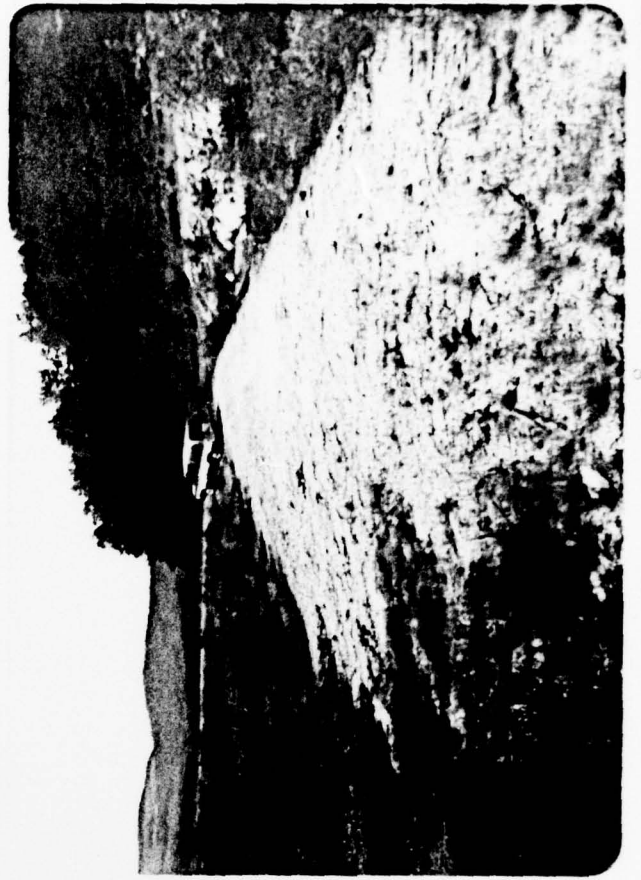
Both the embankment crest and right spillway dike lack adequate protective vegetation. As a result, several areas of minor erosion were noted. The embankment crest is not restricted to vehicular use and some minor rutting was also observed.

PHOTOGRAPH 8    View, looking upstream, of the earth and rock dike which forms the right sidewall of the spillway channel. Note the lack of protective vegetation.

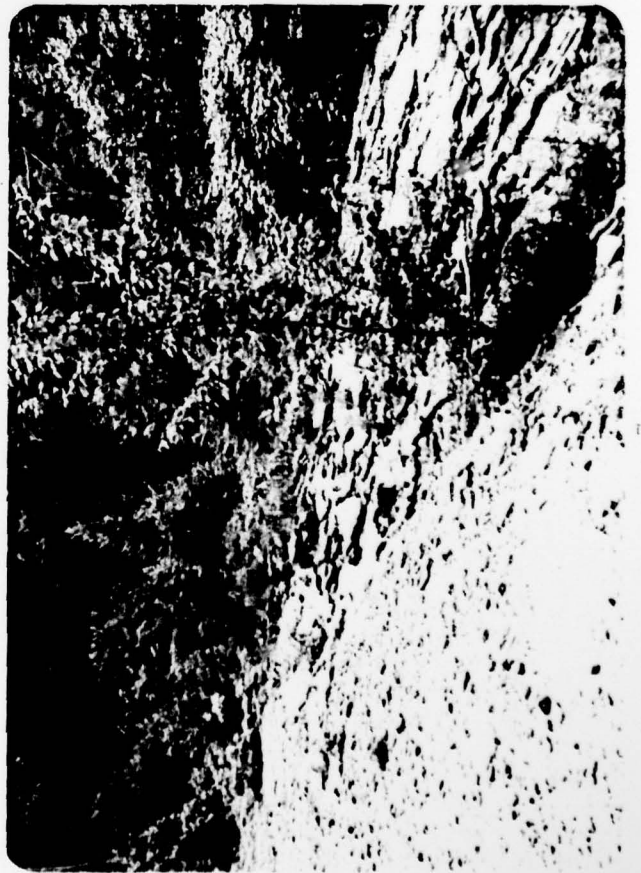
PHOTOGRAPH 6    View, looking downstream, of the spillway discharge channel.

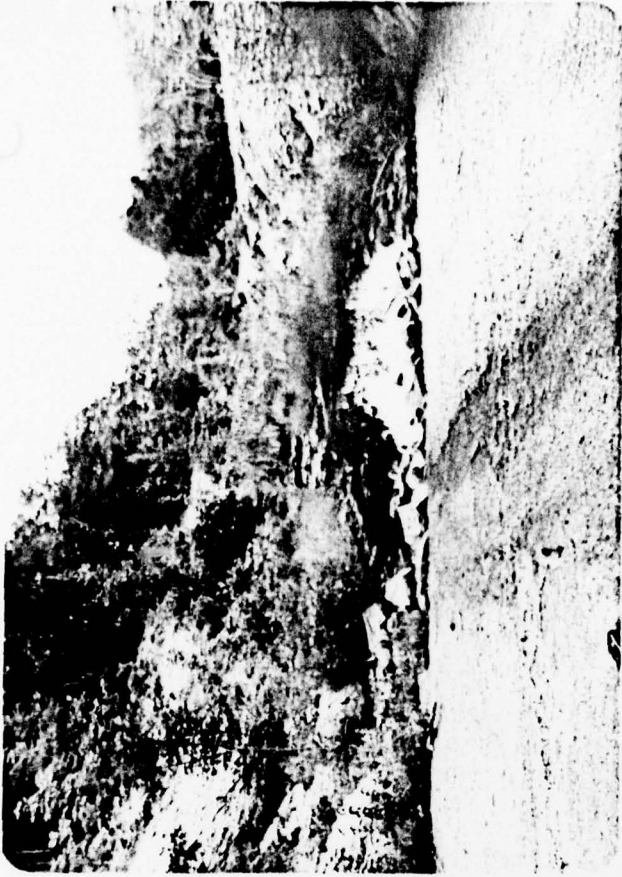
1. Spillway. The spillway, as observed during the visual inspection, appears to be in fair condition. A log bridge has been placed across the approach channel (see Photograph 4) and serves as a potential obstruction to unimpeded spillway discharge as does heavy overgrowth and boulders observed within the discharge channel (see Photograph 6). The concrete overflow weir and sidewalls show signs of cracking, scaling, and overall minor deterioration (see Photograph 4). Water was observed seeping through a crack located near the middle of the left side of the overflow weir (see Photograph 5).

PHOTOGRAPH 5    Close-up view of concrete deterioration associated with the spillway overflow weir and sidewalls.

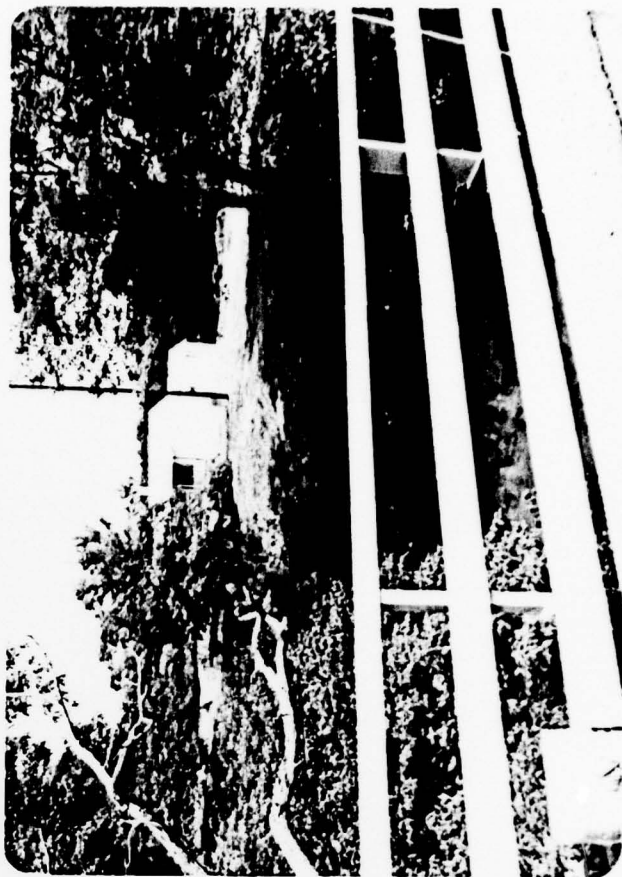
12

View of one residence located near the stream along PA Route 915 approximately 4.5 miles downstream of the embankment.

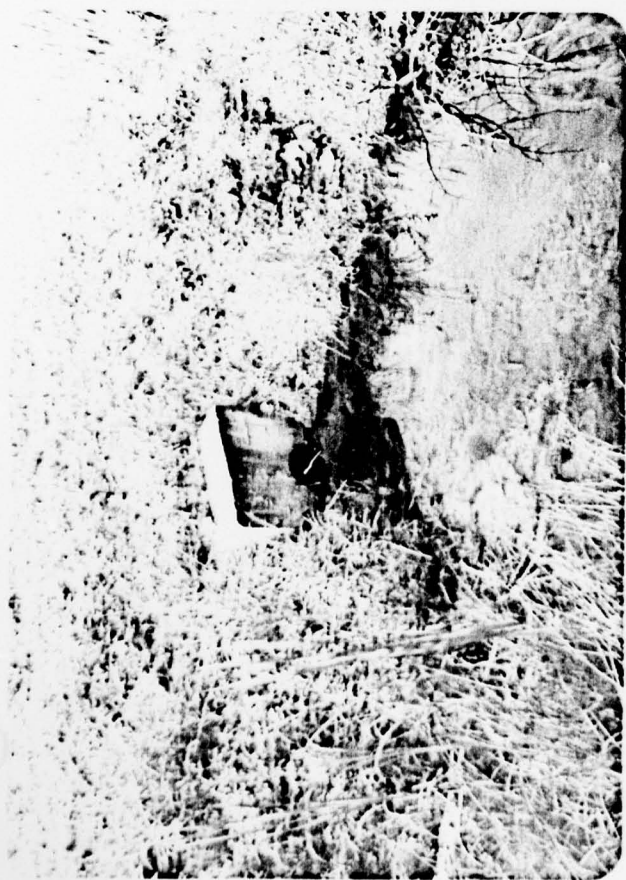
9

2. Outlet Conduit. The only visible portion of the outlet conduit is its discharge end shown in Photograph 9. It is impossible to visually assess the overall condition of the conduit; however, discussions with representatives of

View of the concrete headwall and unlined channel at the discharge end of the outlet conduit located at the downstream embankment toe.

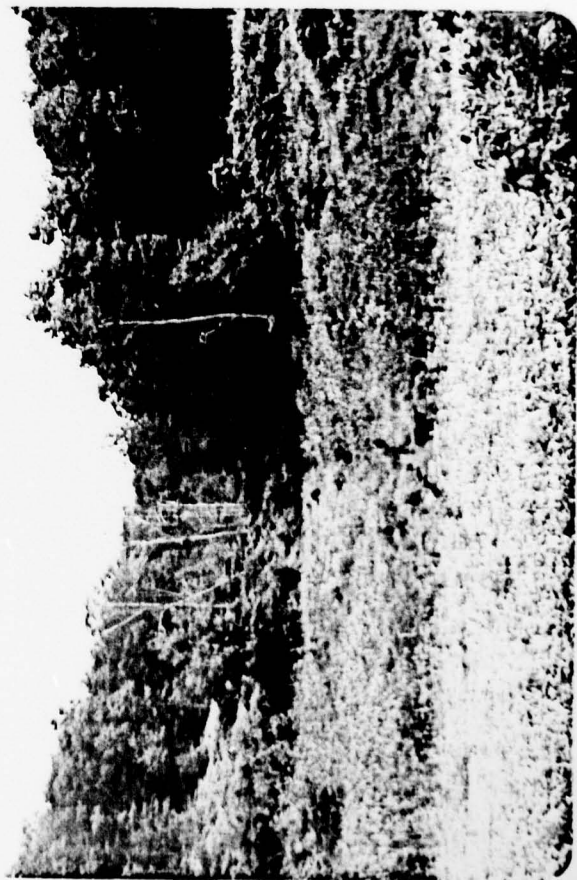
11

e. Downstream Channel. The channel downstream of Valley-Hi Eagle Lake Dam is characterized as a narrow, heavily wooded valley with generally steep confining slopes (see Photograph 11). Oregon Creek merges with Sideling Hill Creek approximately 4 miles downstream of the dam. Within the next mile, in the vicinity of PA Route 915, the creek passes 5 residences which are considered sufficiently close to the stream to be potentially affected by a breach of the embankment (estimated population: 15-20). Thus, the hazard classification of the facility is considered to be high.

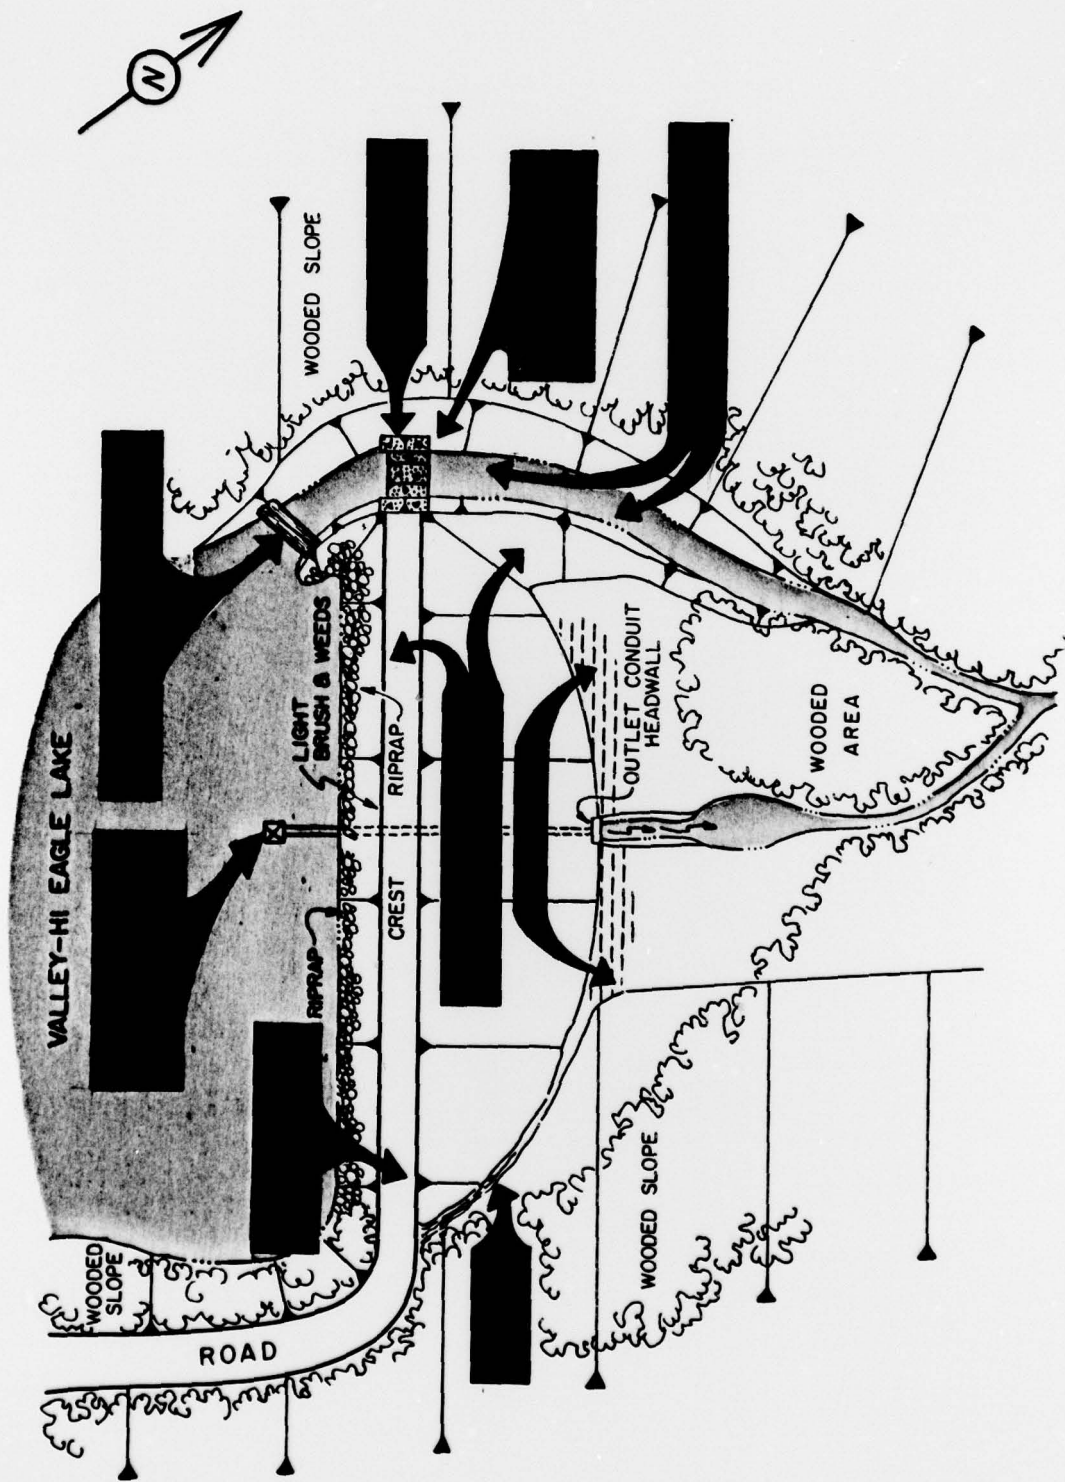
FIGURE 1 - VALLEY-HI EAGLE LAKE  
GENERAL PLAN  
FIELD INSPECTION NOTES

1. Embankment. Details of the design features are based on available correspondence and the field inspection. The actual as-built configuration of the facility is shown on Figure 1. Figures 2 through 4 are design drawings, but have not been revised to show as-built conditions.
